**Flood Control Project Maintenance  
Levee Inspections**

**Fall 2014 Levee Maintenance Deficiency Summary Report**

**Sacramento River Basin**

**Reclamation District No. 0150 Merrit Island**

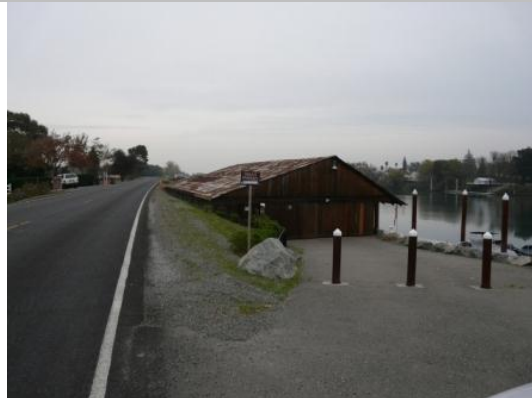
Photo 1 of 1 : FA\_2014\_RD0150\_16\_49\_20141021\_00027.jpg

LM Start	0.16	Rating **	M	Issue No.	49
LM End	0.16	Issue Type +	En	Location *	WS
Category	Earthen Levee			GPS Latitude/Longitude	
				Start	End
Item	Encroachments			38.330047 °	38.330047 °
				-121.574538 °	-121.574538 °
DWR ID	DWR_RD0150_02_s_2012_49				
Action/Comments					
Building

Building located on waterside of levee at LM 0.16

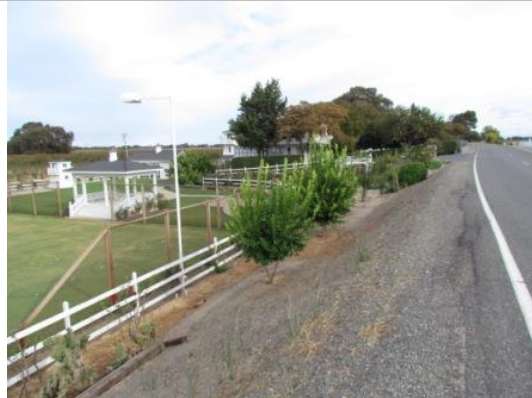
Photo 1 of 1 : FA\_2014\_RD0150\_16\_990\_20141021\_00054.jpg

LM Start	0.17	Rating **	M	Issue No.	990
LM End	0.21	Issue Type +	En	Location *	LS
Category	Earthen Levee			GPS Latitude/Longitude	
				Start	End
Item	Vegetation			38.330173 °	38.330576 °
				-121.574490 °	-121.574093 °
DWR ID	DWR_RD0150_02_s_2012_990				
Action/Comments					
Landscaping

Landscaping was found on the landside of the levee looking upstream.

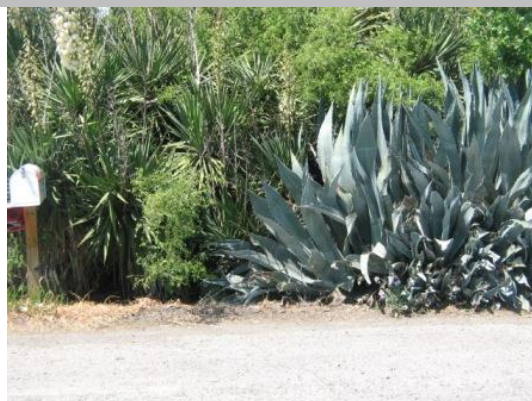
Photo 1 of 1 : FA\_2014\_RD0150\_16\_4\_20141021\_00001.jpg

Landscaping on landward slope at LM 0.25 blocking view of levee slope.

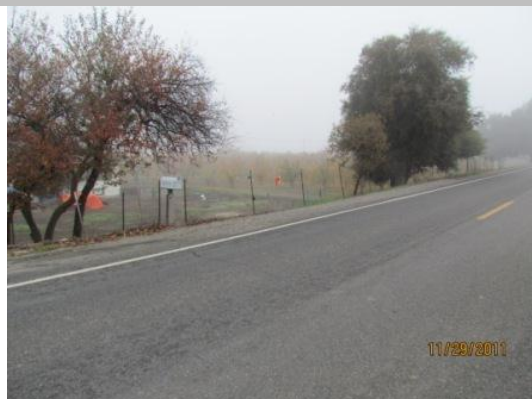
Photo 1 of 1 : FA\_2014\_RD0150\_16\_9\_20141021\_00005.jpg

Fence was found on the landside of the levee looking upstream.

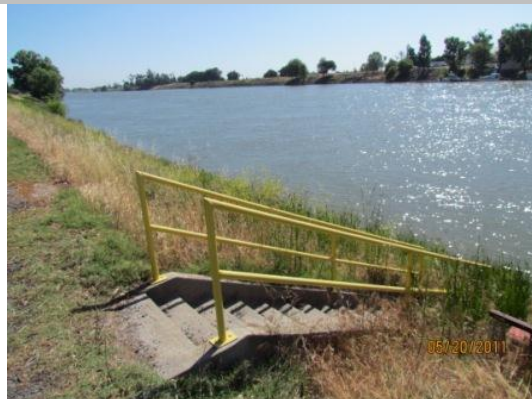
Photo 1 of 1 : FA\_2014\_RD0150\_16\_13\_20141021\_00008.jpg

LM Start	0.39	Rating **	M	Issue No.	13
LM End	0.39	Issue Type +	En	Location *	WS
Category	Earthen Levee			GPS Latitude/Longitude	
				Start	End
Item	Encroachments			38.332647 °	38.332647 °
				-121.572140 °	-121.572140 °
DWR ID	DWR_RD0150_02_s_2012_13				
Action/Comments					
Stairway

A stairway was found on the waterside of the levee. The picture was taken from the crown looking upstream.

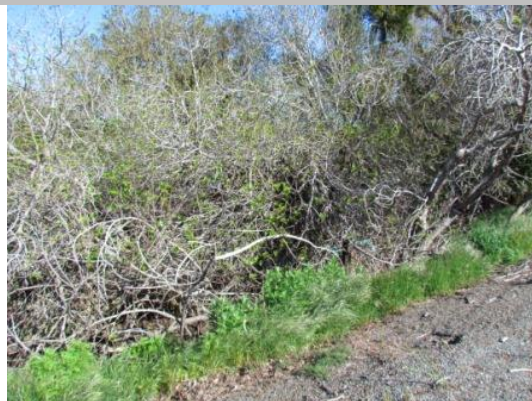
Photo 1 of 1 : FA\_2014\_RD0150\_16\_12\_20141021\_00007.jpg

LM Start	0.98	Rating **	M	Issue No.	12
LM End	0.98	Issue Type +	En	Location *	LS
Category	Earthen Levee			GPS Latitude/Longitude	
				Start	End
Item	Encroachments			38.339035 °	38.339035 °
				-121.565145 °	-121.565145 °
DWR ID	DWR_RD0150_02_s_2012_12				
Action/Comments					
Tree or limb

Overgrown trees were obstructing the landside slope of the levee looking upstream.

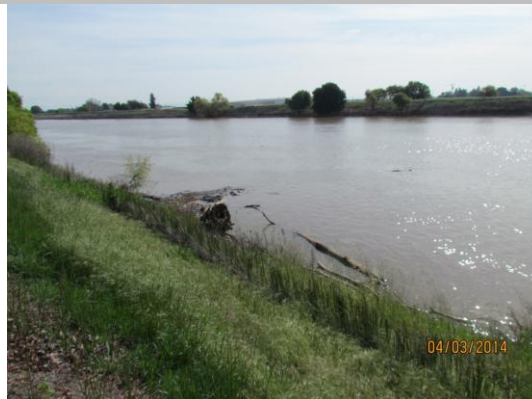
Photo 1 of 2 : FA\_2014\_RD0150\_16\_18\_20141021\_00012.jpg

LM Start	1.00	Rating **	M	Issue No.	18
LM End	1.00	Issue Type +	Ma	Location *	WS
Category	Earthen Levee			GPS Latitude/Longitude	
				Start	End
Item	Encroachments			38.339268 °	38.339268 °
				-121.564839 °	-121.564839 °
DWR ID	DWR_RD0150_02_s_2013_18				
Action/Comments					
Tree or limb					
Inspector Comments: Tree trunk was found on the waterside toe of the levee.

Updated picture of the tree trunk on the waterside toe of the levee looking upstream during spring 2014 inspection.

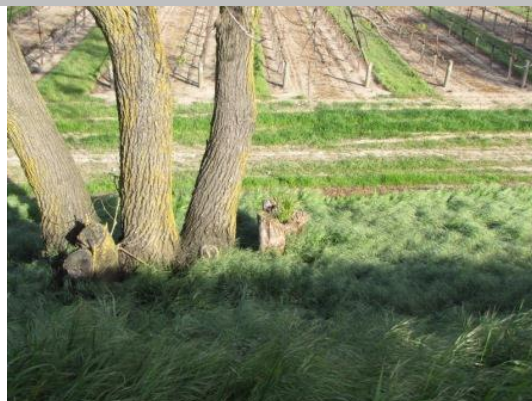
Photo 1 of 1 : FA\_2014\_RD0150\_16\_8\_20141021\_00004.jpg

LM Start	1.16	Rating **	N	Issue No.	8
LM End	1.16	Issue Type +	Ma	Location *	LS
Category	Earthen Levee			GPS Latitude/Longitude	
				Start	End
Item	Trim / Thin Trees			38.340864 °	38.340864 °
				-121.562915 °	-121.562915 °
DWR ID	DWR_RD0150_02_s_2012_8				
Action/Comments					
Tree stumps.

View of a tree stump on the landward slope.

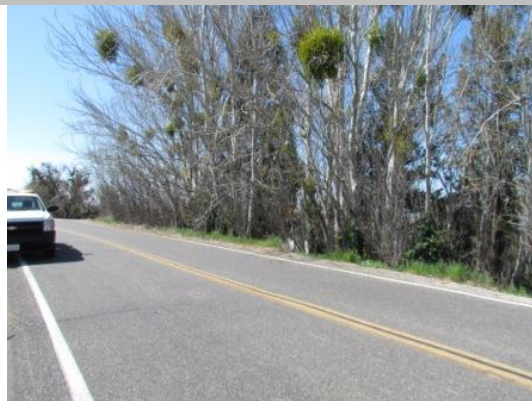
Photo 1 of 2 : FA\_2014\_RD0150\_16\_91\_20141021\_00042.jpg

LM Start	1.34	Rating **	M	Issue No.	91
LM End	1.37	Issue Type +	En	Location *	LS
Category	Earthen Levee			GPS Latitude/Longitude	
				Start	End
Item	Vegetation			38.342969 °	38.343252 °
				-121.561196 °	-121.560794 °
DWR ID	DWR_RD0150_02_s_2012_91				
Action/Comments					
Landscaping

Landscaping was obstructing the view of the landside slope of the levee looking downstream. This picture was taken during spring 2013 inspection.

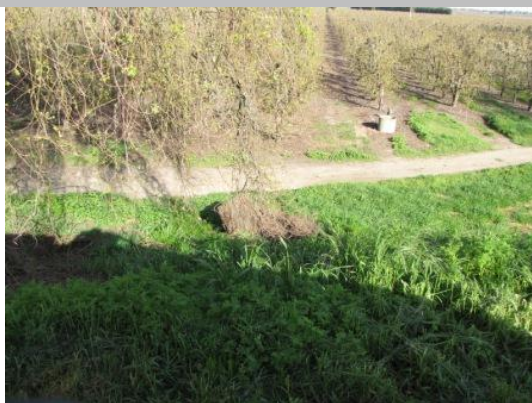
Photo 1 of 1 : FA\_2014\_RD0150\_16\_14\_20141021\_00009.jpg

LM Start	2.80	Rating **	N	Issue No.	14
LM End	2.80	Issue Type +	Ma	Location *	LS
Category	Earthen Levee			GPS Latitude/Longitude	
				Start	End
Item	Trim / Thin Trees			38.350041 °	38.350041 °
				-121.536853 °	-121.536853 °
DWR ID	DWR_RD0150_02_s_2012_14				
Action/Comments					
Tree stumps.

View of a tree stump on the landward slope.

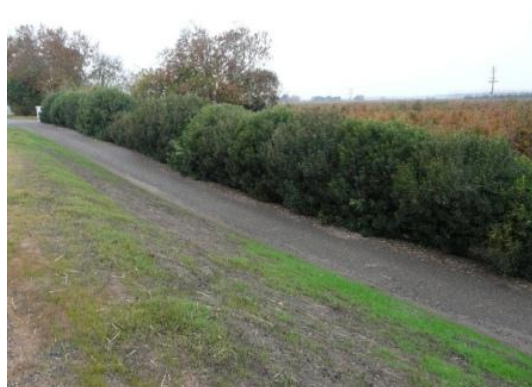
Photo 1 of 1 : FA\_2014\_RD0150\_16\_85\_20141021\_00040.jpg

LM Start	3.02	Rating **	U	Issue No.	85
LM End	3.06	Issue Type +	En	Location *	LS
Category	Earthen Levee			GPS Latitude/Longitude	
				Start	End
Item	Vegetation			38.352372 °	38.352802 °
				-121.534127 °	-121.533638 °
DWR ID	DWR_RD0150_02_s_2012_85				
Action/Comments					
Landscaping

Landscaping providing a screen for a residence on landside of levee  
from LM 3.02 to LM 3.06

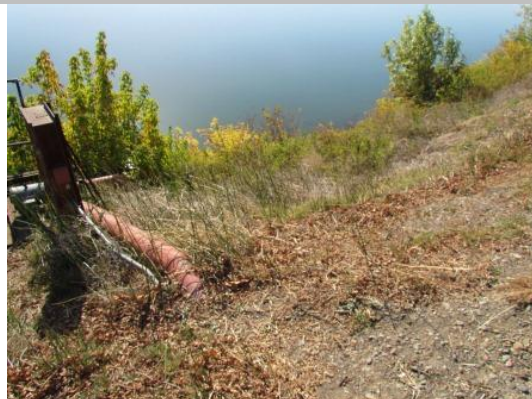
Photo 1 of 6 : FA\_2014\_RD0150\_16\_961\_20141021\_00047.jpg

View of the erosion on the waterside slope of the levee near the pipe looking downstream. This picture was taken during the fall 2013 inspection.

LM Start	3.29	Rating **	M	Issue No.	961
LM End	3.29	Issue Type +	Ma	Location *	WS
Category	Earthen Levee			GPS Latitude/Longitude	
				Start	End
Item	Erosion / Bank Caving			38.355321 °	38.355321 °
				-121.530902 °	-121.530902 °
DWR ID	DWR_RD0150_02_s_2012_961				
Action/Comments					
Schedule repair of erosion site prior to the next inspection. Inspector Comments: Depressions into the waterward slope can be seen along the waterward slope at this site. Also note the damaged pump support, pump, and pipe just upstream of the site; they may contribute to the erosion in a high water event and should be removed.

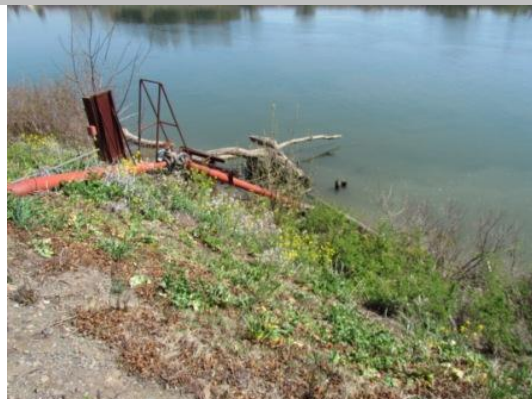
Photo 2 of 6 : FA\_2014\_RD0150\_16\_961\_20141021\_00049.jpg

View of the erosion on the waterside slope of the levee looking upstream during spring 2013 inspection.

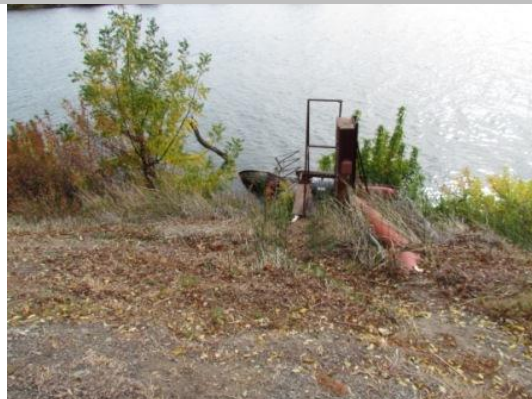
Photo 3 of 6 : FA\_2014\_RD0150\_16\_961\_20141021\_00048.jpg

View of erosion and damaged pipe and abandoned boat on the waterside of the levee looking upstream. This picture was taken during fall 2012 inspection.

LM Start	3.29	Rating **	M	Issue No.	961 (cont)	
LM End	3.29	Issue Type +	Ma	Location *	WS	
Category	Earthen Levee			GPS Latitude/Longitude		
				Start		End
Item	Erosion / Bank Caving			38.355321 °		38.355321 °
				-121.530902 °		-121.530902 °
DWR ID	DWR_RD0150_02_s_2012_961					
Action/Comments						
Schedule repair of erosion site prior to the next inspection. Inspector Comments: Depressions into the waterward slope can be seen along the waterward slope at this site. Also note the damaged pump support, pump, and pipe just upstream of the site; they may contribute to the erosion in a high water event and should be removed.

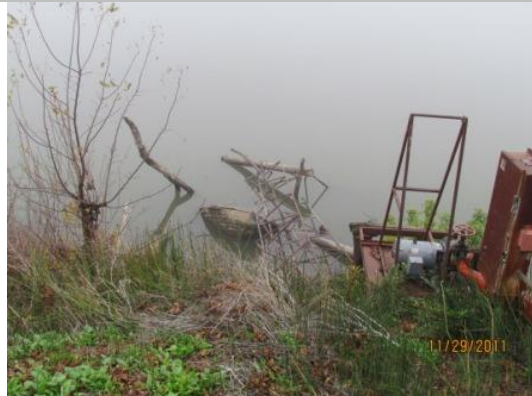
Photo 4 of 6 : FA\_2014\_RD0150\_16\_961\_20141021\_00050.jpg

View of the erosion site, and broken pump support along with a boat on the waterside of the levee. The picture was taken from the crown looking towards the toe of the levee during fall 2011 inspection.

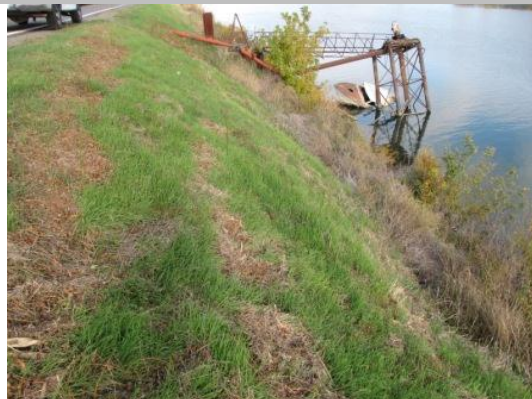
Photo 5 of 6 : FA\_2014\_RD0150\_16\_961\_20141021\_00045.jpg

View of erosion on the waterward slope looking upstream. Depressions into the slope can be seen in several places.

LM Start	3.29	Rating **	M	Issue No.	961 (cont)	
LM End	3.29	Issue Type +	Ma	Location *	WS	
Category	Earthen Levee			GPS Latitude/Longitude		
				Start		End
Item	Erosion / Bank Caving			38.355321 °	38.355321 °	
				-121.530902 °	-121.530902 °	
DWR ID	DWR_RD0150_02_s_2012_961					
Action/Comments						
Schedule repair of erosion site prior to the next inspection. Inspector Comments: Depressions into the waterward slope can be seen along the waterward slope at this site. Also note the damaged pump support, pump, and pipe just upstream of the site; they may contribute to the erosion in a high water event and should be removed.

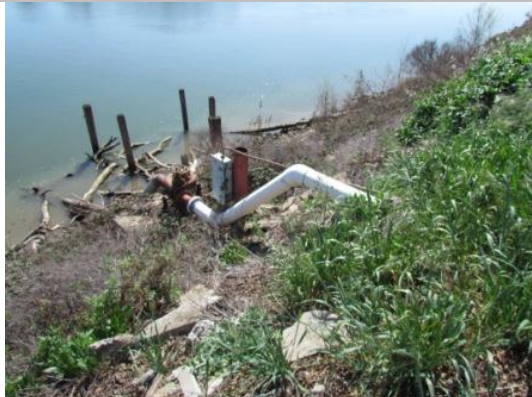
Photo 1 of 2 : FA\_2014\_RD0150\_16\_15\_20141021\_00010.jpg

LM Start	3.56	Rating **	A/W	Issue No.	15
LM End	3.56	Issue Type +	En	Location *	CR
Category	Earthen Levee			GPS Latitude/Longitude	
				Start	End
Item	Encroachments			38.358152 °	38.358152 °
				-121.527579 °	-121.527579 °
DWR ID	DWR_RD0150_02_s_2012_15				
Action/Comments					
Pipe					
Inspector Comments: PVC pipe is sleeving through an old steel pipe.					
The steel pipe appears to be fine for now, but we should keep an eye on it.

A PVC pipe was used to pump the water from waterside of the levee. It appeared that the PVC pipe was penetrating through a corroded steel casing through the levee crown. The picture was taken from the crown of the levee looking upstream during spring 2013 inspection.

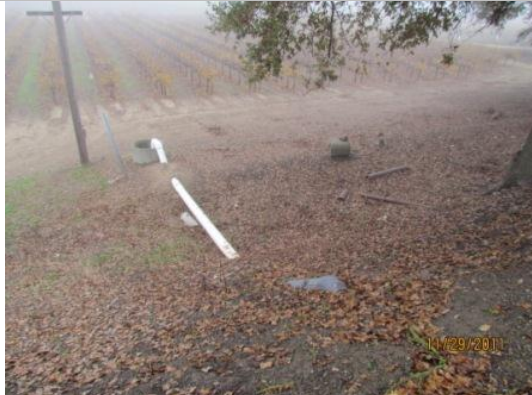
Photo 2 of 2 : FA\_2014\_RD0150\_16\_15\_20141021\_00011.jpg

A PVC pipe was used under the levee crown for irrigation purpose. The picture was taken from the crown looking downstream.

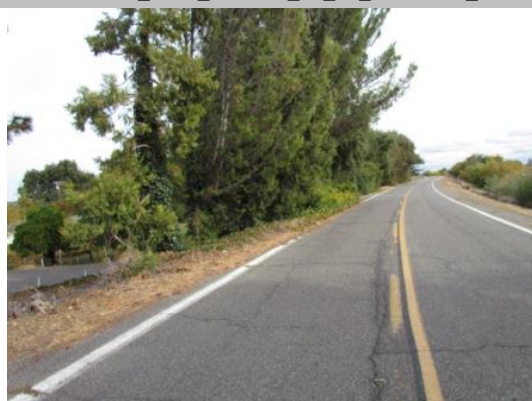
Photo 1 of 1 : FA\_2014\_RD0150\_16\_82\_20141021\_00039.jpg

Landscaping was blocking the visibility on the landside of the levee looking upstream.

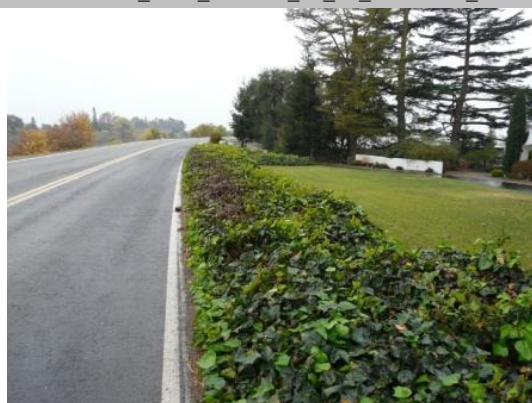
Photo 1 of 1 : FA\_2014\_RD0150\_16\_80\_20141021\_00038.jpg

Landscaping in front of a residence on landside of levee from LM 3.90 to LM 3.93. The levee in this location is greater than 100' wide.

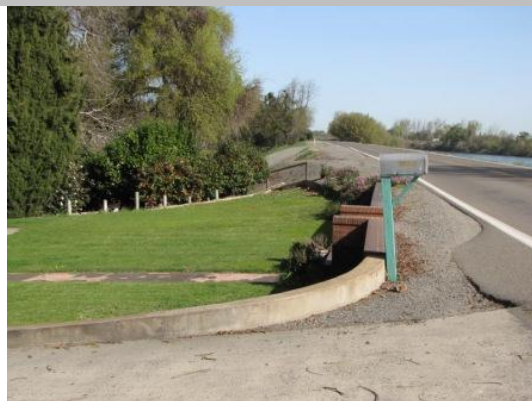
Photo 1 of 1 : FA\_2014\_RD0150\_16\_20\_20141021\_00014.jpg

View of a retaining wall on the landward slope looking upstream.

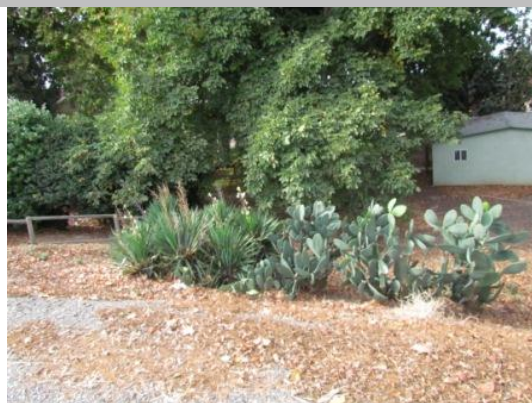
Photo 1 of 1 : FA\_2014\_RD0150\_16\_953\_20141021\_00044.jpg

View of cacti on the landside of the levee looking from the crown.

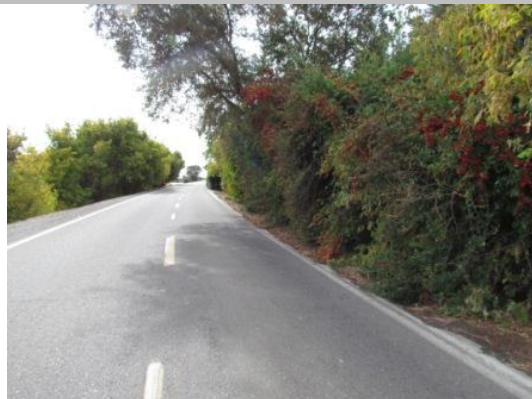
Photo 1 of 1 : FA\_2014\_RD0150\_16\_79\_20141021\_00037.jpg

LM Start	4.37	Rating **	U	Issue No.	79
LM End	4.41	Issue Type +	En	Location *	LS
Category	Earthen Levee			GPS Latitude/Longitude	
				Start	End
Item	Vegetation			38.368036 °	38.368540 °
				-121.522611 °	-121.522729 °
DWR ID	DWR_RD0150_02_s_2012_79				
Action/Comments					
Landscaping

Trees were obstructing the views on the landside slope of the levee looking downstream.

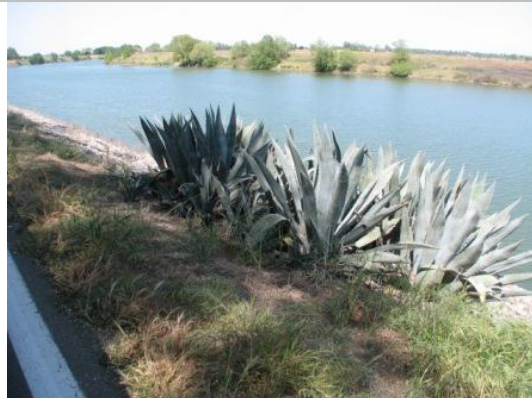
Photo 1 of 1 : FA\_2014\_RD0150\_16\_28\_20141021\_00018.jpg

Century plant on waterward slope at LM 4.76

LM Start	4.76	Rating **	M	Issue No.	28
LM End	4.76	Issue Type +	Ma	Location *	WS
Category	Earthen Levee			GPS Latitude/Longitude	
				Start	End
Item	Vegetation			38.373485 °	38.373485 °
				-121.523963 °	-121.523963 °
DWR ID	DWR_RD0150_02_s_2012_28				
Action/Comments					
Remove the wild growth other than native grasses from the levee slopes.

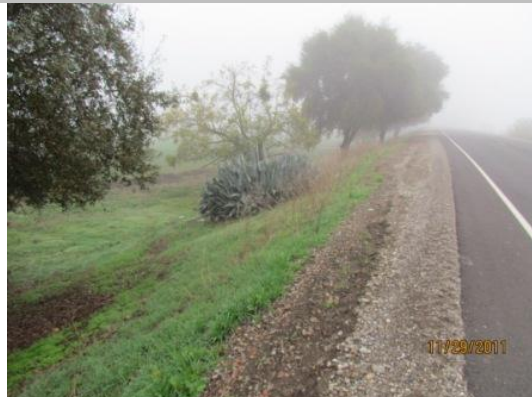
Photo 1 of 1 : FA\_2014\_RD0150\_16\_27\_20141021\_00017.jpg

LM Start	6.41	Rating **	M	Issue No.	27
LM End	6.41	Issue Type +	En	Location *	LS
Category	Earthen Levee			GPS Latitude/Longitude	
				Start	End
Item	Vegetation			38.393655 °	38.393655 °
				-121.514654 °	-121.514654 °
DWR ID	DWR_RD0150_02_s_2012_27				
Action/Comments					
Landscaping					
Inspector Comments: Century plant on the landward slope.

Century plant was found on the landside of the levee looking upstream.

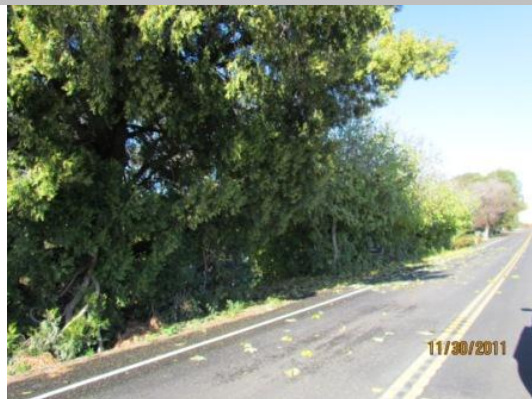
Photo 1 of 1 : FA\_2014\_RD0150\_16\_31\_20141021\_00020.jpg

LM Start	6.46	Rating **	M	Issue No.	31
LM End	6.46	Issue Type +	En	Location *	LS
Category	Earthen Levee			GPS Latitude/Longitude	
				Start	End
Item	Vegetation			38.394416 °	38.394416 °
				-121.514590 °	-121.514590 °
DWR ID	DWR_RD0150_02_s_2012_31				
Action/Comments					
Landscaping

Trees need to be trimmed on the landside of the levee looking upstream.

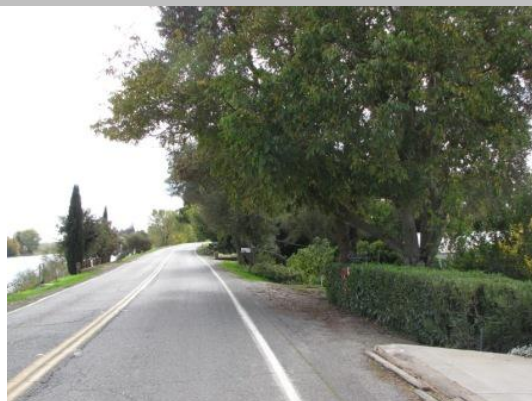
Photo 1 of 1 : FA\_2014\_RD0150\_16\_65\_20141021\_00033.jpg

LM Start	6.50	Rating **	M	Issue No.	65
LM End	6.57	Issue Type +	En	Location *	LS
Category	Earthen Levee			GPS Latitude/Longitude	
				Start	End
Item	Vegetation			38.394935 °	38.395931 °
				-121.514597 °	-121.514604 °
DWR ID	DWR_RD0150_02_s_2012_65				
Action/Comments					
Landscaping

View of landscaping along the waterward shoulder and slope looking downstream.

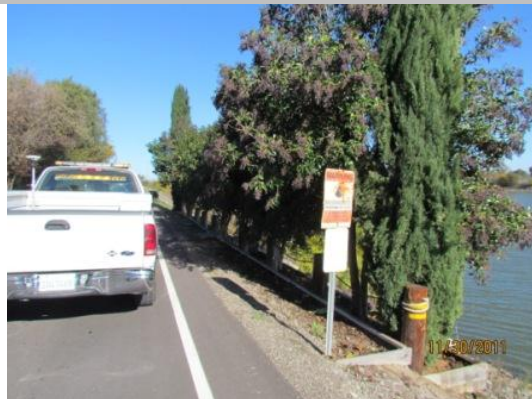
Photo 1 of 1 : FA\_2014\_RD0150\_16\_34\_20141021\_00022.jpg

LM Start	6.53	Rating **	M	Issue No.	34
LM End	6.53	Issue Type +	En	Location *	WS
Category	Earthen Levee			GPS Latitude/Longitude	
				Start	End
Item	Vegetation			38.395340 °	38.395340 °
				-121.514528 °	-121.514528 °
DWR ID	DWR_RD0150_02_s_2012_34				
Action/Comments					
Landscaping

Landscaping was found on the waterside of the levee looking upstream.

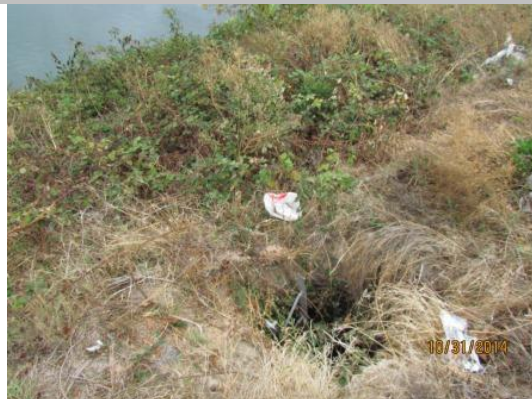
Photo 1 of 1 : FA\_2014\_RD0150\_16\_55\_20141104\_00077.jpg

An open pipe valve was found without a cover on the waterside toe of the levee.

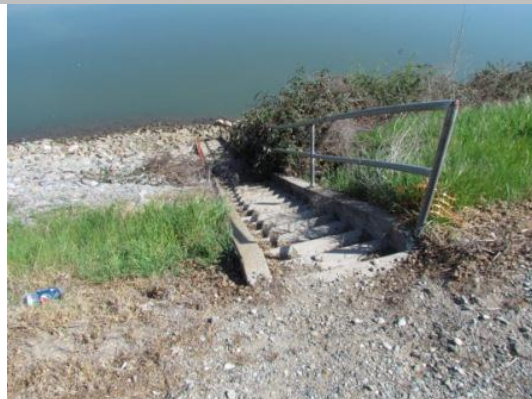
Photo 1 of 1 : FA\_2014\_RD0150\_16\_38\_20141021\_00023.jpg

LM Start	6.83	Rating **	M	Issue No.	38
LM End	6.83	Issue Type +	En	Location *	WS
Category	Earthen Levee			GPS Latitude/Longitude	
				Start	End
Item	Encroachments			38.399623 °	38.399623 °
				-121.514877 °	-121.514877 °
DWR ID	DWR_RD0150_02_s_2013_38				
Action/Comments					
Stairway

A stairway was found on the waterside slope of the levee looking upstream during spring 2013 inspection.

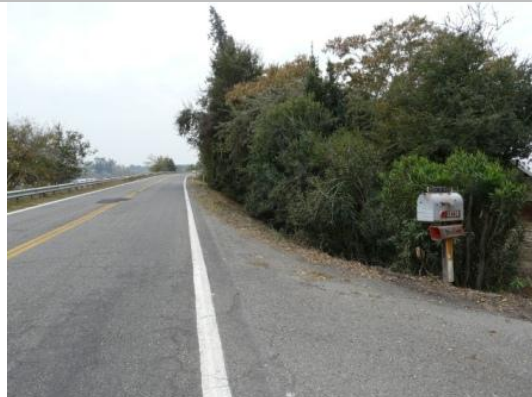
Photo 1 of 1 : FA\_2014\_RD0150\_16\_60\_20141021\_00031.jpg

LM Start	6.93	Rating **	U	Issue No.	60
LM End	7.05	Issue Type +	En	Location *	LS
Category	Earthen Levee			GPS Latitude/Longitude	
				Start	End
Item	Vegetation			38.400936 °	38.402613 °
				-121.515173 °	-121.515863 °
DWR ID	DWR_RD0150_02_s_2012_60				
Action/Comments					
Landscaping

Landscaping providing a screen for a residence on the landside of levee from LM 6.93 to LM 7.05

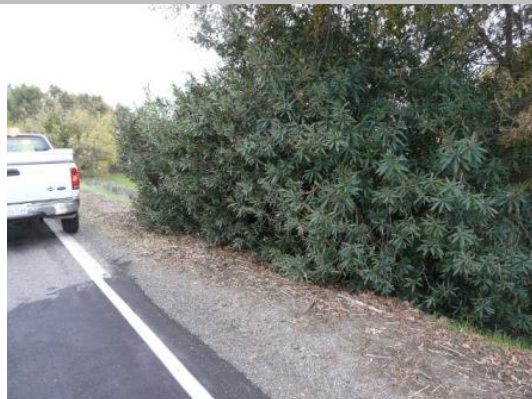
Photo 1 of 1 : FA\_2014\_RD0150\_16\_58\_20141021\_00030.jpg

LM Start	7.12	Rating **	M	Issue No.	58
LM End	7.12	Issue Type +	En	Location *	LS
Category	Earthen Levee			GPS Latitude/Longitude	
				Start	End
Item	Vegetation			38.403631 °	38.403631 °
				-121.516299 °	-121.516299 °
DWR ID	DWR_RD0150_02_s_2012_58				
Action/Comments					
Landscaping

Landscaping providing a screen for a residence on landside of levee at LM 7.12

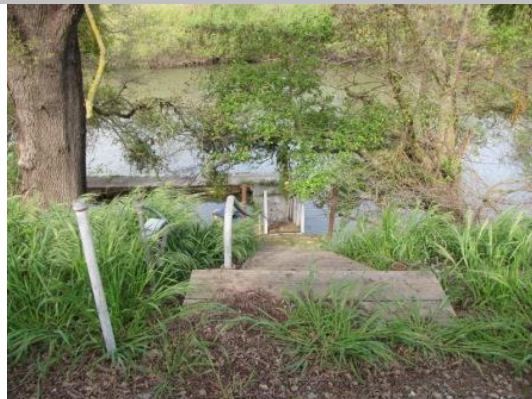
Photo 1 of 1 : FA\_2014\_RD0150\_17\_3\_20141021\_00001.jpg

LM Start	0.36	Rating **	M	Issue No.	3
LM End	0.36	Issue Type +	En	Location *	WS
Category	Earthen Levee			GPS Latitude/Longitude	
				Start	End
Item	Encroachments			38.337442 °	38.337442 °
				-121.581628 °	-121.581628 °
DWR ID	DWR_RD0150_03_s_2012_3				
Action/Comments					
Building Inspector Comments: Steps, water, electricity, and dock on waterward slope.

View of steps, a dock, and associated utilities on the waterward slope.

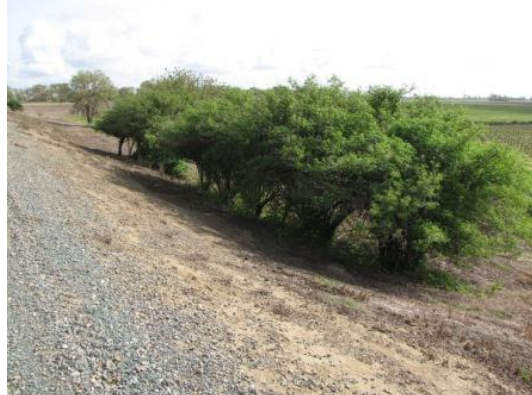
Photo 1 of 1 : FA\_2014\_RD0150\_17\_5\_20141021\_00004.jpg

LM Start	0.92	Rating **	A/W	Issue No.	5
LM End	0.95	Issue Type +	Ma	Location *	LS
Category	Earthen Levee			GPS Latitude/Longitude	
				Start	End
Item	Vegetation			38.345293 °	38.345634 °
				-121.579769 °	-121.579574 °
DWR ID	DWR_RD0150_03_s_2012_5				
Action/Comments					
Elderberries are blocking visibility and flood fight capability.

View of elderberries on the landward slope blocking visibility and access.

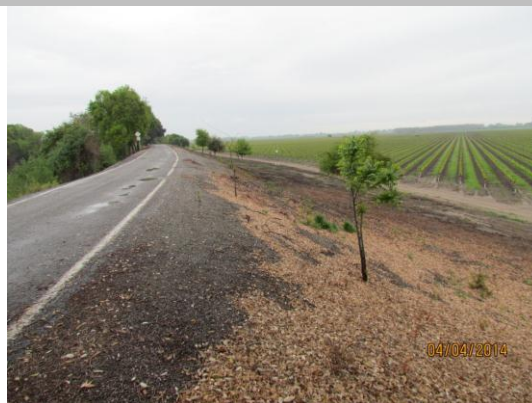
Photo 1 of 5 : FA\_2014\_RD0150\_17\_78\_20141021\_00078.jpg

LM Start	2.34	Rating **	M	Issue No.	78
LM End	2.34	Issue Type +	En	Location *	LS
Category	Earthen Levee			GPS Latitude/Longitude	
				Start	End
Item	Encroachments			38.354286 °	38.354286 °
				-121.564494 °	-121.564494 °
DWR ID	DWR_RD0150_03_s_2012_78				
Action/Comments					
Tree or limb					
Inspector Comments: New tree was planted on the landside slope.

View of the newly planted tree on the landside slope of the levee during spring 2014 inspection.

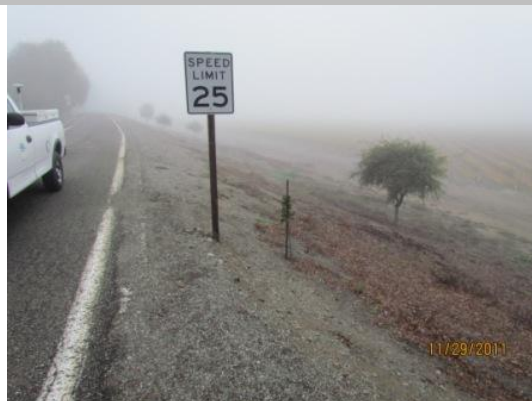
Photo 5 of 5 : FA\_2014\_RD0150\_17\_78\_20141021\_00082.jpg

New tree has been planted on the landside slope of the levee looking upstream.

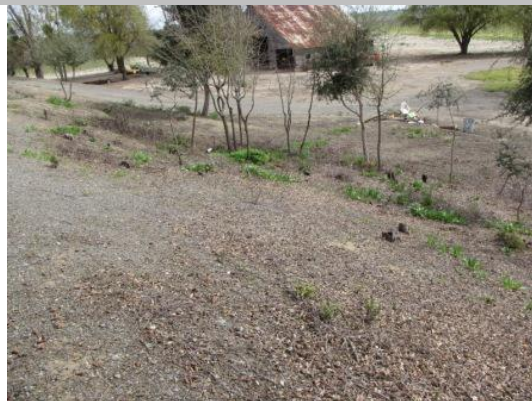
Photo 1 of 1 : FA\_2014\_RD0150\_17\_11\_20141021\_00007.jpg

LM Start	2.60	Rating **	N	Issue No.	11
LM End	2.60	Issue Type +	Ma	Location *	LS
Category	Earthen Levee			GPS Latitude/Longitude	
				Start	End
Item	Trim / Thin Trees			38.356853 °	38.356853 °
				-121.561565 °	-121.561565 °
DWR ID	DWR_RD0150_03_s_2012_11				
Action/Comments					
Tree stumps.

View of tree stumps on the landward slope.

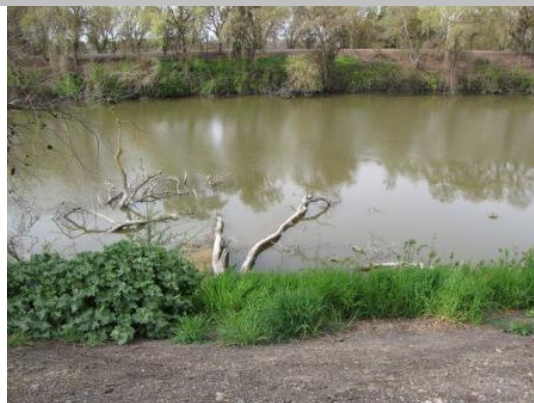
Photo 1 of 1 : FA\_2014\_RD0150\_17\_17\_20141021\_00014.jpg

LM Start	2.87	Rating **	N	Issue No.	17
LM End	2.87	Issue Type +	Ma	Location *	WS
Category	Earthen Levee			GPS Latitude/Longitude	
				Start	End
Item	Trim / Thin Trees			38.360621 °	38.360621 °
				-121.561762 °	-121.561762 °
DWR ID	DWR_RD0150_03_s_2012_17				
Action/Comments					
Tree stumps.

View of tree stumps on the waterward slope.

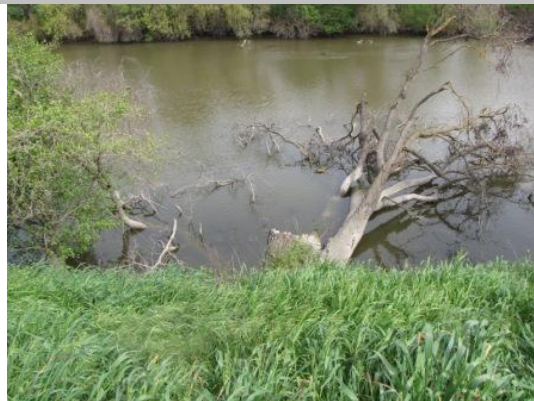
Photo 1 of 1 : FA\_2014\_RD0150\_17\_20\_20141021\_00015.jpg

View of tree stumps on the waterward slope.

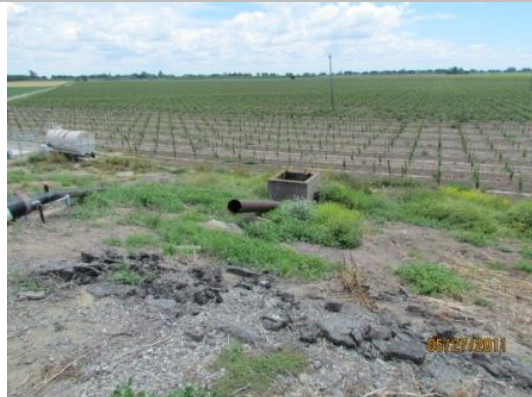
Photo 1 of 1 : FA\_2014\_RD0150\_17\_39\_20141021\_00031.jpg

LM Start	3.34	Rating **	M	Issue No.	39
LM End	3.34	Issue Type +	En	Location *	LS
Category	Earthen Levee			GPS Latitude/Longitude	
				Start	End
Item	Encroachments			38.363043 °	38.363043 °
				-121.557316 °	-121.557316 °
DWR ID	DWR_RD0150_03_s_2012_39				
Action/Comments					
Pipe

An abandoned pipe was located on the landside of the levee. The picture was taken from the crown looking downstream.

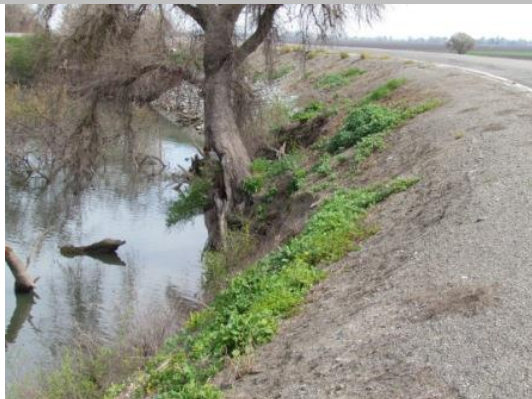
Photo 2 of 2 : FA\_2014\_RD0150\_17\_40\_20141021\_00032.jpg

Erosion was found on the waterside toe of the levee looking upstream during spring 2013 inspection.

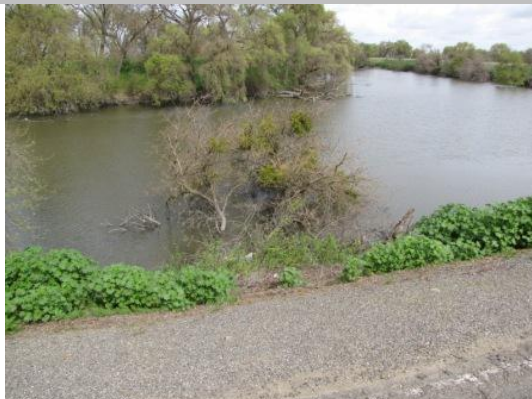
Photo 1 of 1 : FA\_2014\_RD0150\_17\_27\_20141021\_00019.jpg

View of tree stumps on the waterside slope looking upstream.

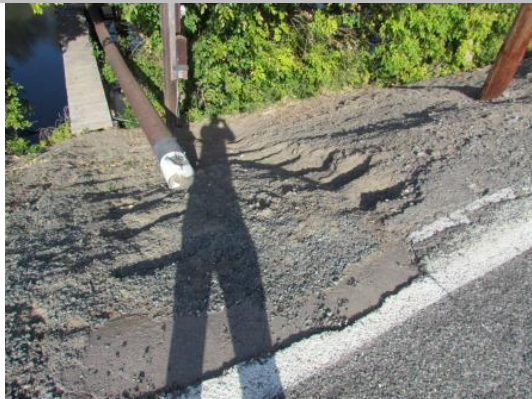
Photo 1 of 1 : FA\_2014\_RD0150\_17\_114\_20141021\_00093.jpg

View of steps that were dug on the waterside slope of the levee looking upstream.

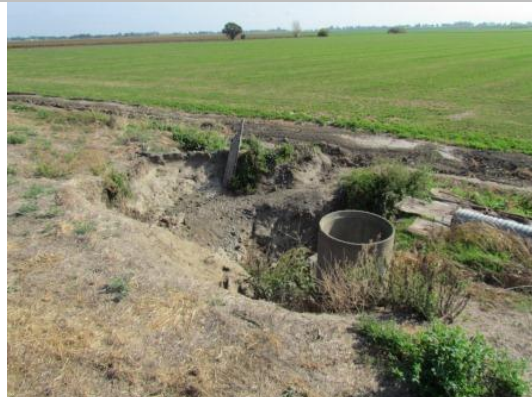
Photo 1 of 1 : FA\_2014\_RD0150\_17\_115\_20141021\_00094.jpg

LM Start	3.45	Rating **	U	Issue No.	115
LM End	3.45	Issue Type +	Ma	Location *	LS
Category	Earthen Levee			GPS Latitude/Longitude	
				Start	End
Item	Erosion / Bank Caving			38.363540 °	38.363540 °
				-121.555554 °	-121.555554 °
DWR ID	DWR_RD0150_03_f_2013_115				
Action/Comments					
Schedule repair of erosion site prior to the next inspection. Inspector Comments: Erosion was found on the landside toe of the levee.

A drainage ditch with depth of 4 feet and width of 15 feet was found on the landside toe of the levee. The picture was taken from the landside slope looking upstream during the fall 2013 inspection.

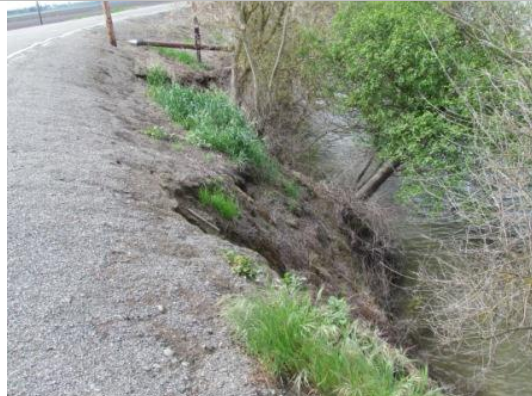
Photo 1 of 1 : FA\_2014\_RD0150\_17\_98\_20141021\_00092.jpg

LM Start	3.47	Rating **	M	Issue No.	98
LM End	3.47	Issue Type +	Ma	Location *	WS
Category	Earthen Levee			GPS Latitude/Longitude	
				Start	End
Item	Erosion / Bank Caving			38.363803 °	38.363803 °
				-121.555432 °	-121.555432 °
DWR ID	DWR_RD0150_03_s_2012_98				
Action/Comments					
Note and monitor erosion site. Inspector Comments: Erosion was located on the waterside of the levee looking downstream.

Erosion was found on the waterside of the levee looking downstream.

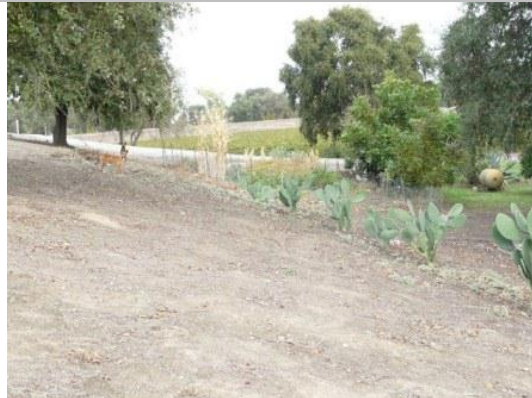
Photo 1 of 1 : FA\_2014\_RD0150\_17\_47\_20141021\_00036.jpg

LM Start	3.50	Rating **	M	Issue No.	47
LM End	3.54	Issue Type +	En	Location *	LS
Category	Earthen Levee			GPS Latitude/Longitude	
				Start	End
Item	Vegetation			38.364251 °	38.364772 °
				-121.555321 °	-121.555343 °
DWR ID	DWR_RD0150_03_s_2012_47				
Action/Comments					
Landscaping

Landscaping & garden on landward slope of levee at LM 3.50 to LM 3.54.

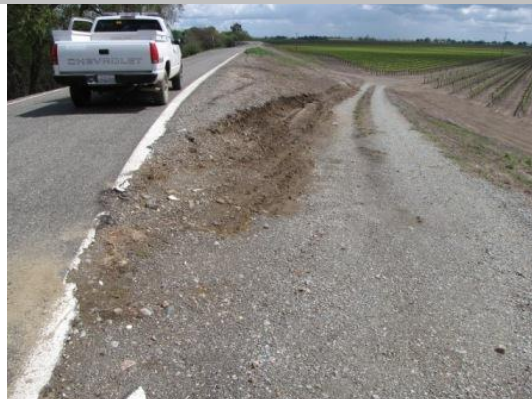
Photo 2 of 2 : FA\_2014\_RD0150\_17\_927\_20141021\_00098.jpg

LM Start	3.75	Rating **	A/W	Issue No.	927 (cont)	
LM End	3.75	Issue Type +	Ma	Location *	LS	
Category	Earthen Levee			GPS Latitude/Longitude		
				Start		End
Item	Slope Stability			38.367305 °		38.367305 °
				-121.554984 °		-121.554984 °
DWR ID	DWR_RD0150_03_s_2012_927					
Action/Comments						
Repair the levee slope damaged by vehicle traffic and prevent access where possible.

Repair minor damage to levee slope along landward ramp at LM 3.75.

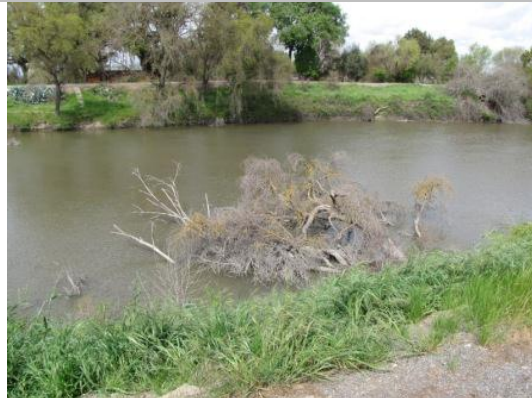
Photo 1 of 1 : FA\_2014\_RD0150\_17\_37\_20141021\_00030.jpg

LM Start	4.35	Rating **	N	Issue No.	37
LM End	4.35	Issue Type +	Ma	Location *	WS
Category	Earthen Levee			GPS Latitude/Longitude	
				Start	End
Item	Trim / Thin Trees			38.373319 °	38.373319 °
				-121.550836 °	-121.550836 °
DWR ID	DWR_RD0150_03_s_2012_37				
Action/Comments					
Tree stumps.

View of tree stumps on the waterward slope.

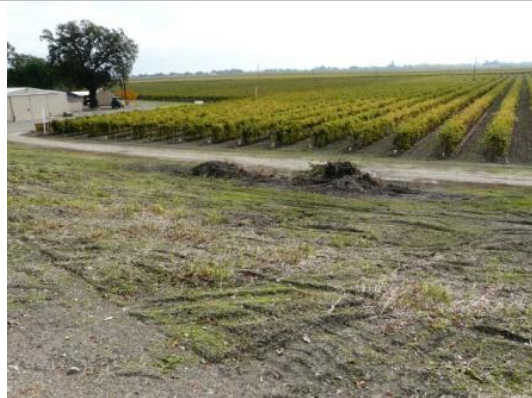
Photo 1 of 4 : FA\_2014\_RD0150\_17\_51\_20141021\_00043.jpg

LM Start	4.46	Rating **	M	Issue No.	51
LM End	4.46	Issue Type +	Ma	Location *	LS
Category	Earthen Levee			GPS Latitude/Longitude	
				Start	End
Item	Encroachments			38.374269 °	38.374269 °
				-121.549385 °	-121.549385 °
DWR ID	DWR_RD0150_03_s_2012_51				
Action/Comments					
Prunings

Remove pruning pile on landward slope at LM 4.46.

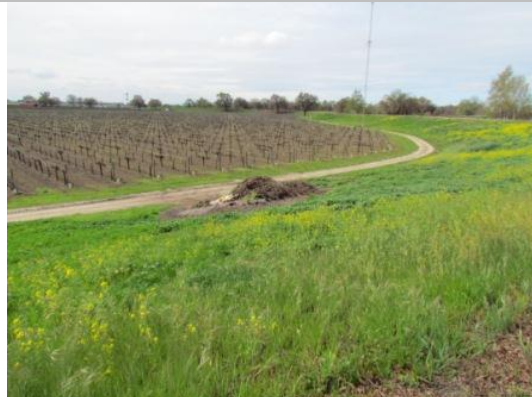
Photo 2 of 4 : FA\_2014\_RD0150\_17\_51\_20141021\_00044.jpg

LM Start	4.46	Rating **	M	Issue No.	51 (cont)	
LM End	4.46	Issue Type +	Ma	Location *	LS	
Category	Earthen Levee			GPS Latitude/Longitude		
				Start		End
Item	Encroachments			38.374269 °		38.374269 °
				-121.549385 °		-121.549385 °
DWR ID	DWR_RD0150_03_s_2012_51					
Action/Comments						
Prunings

Prunings were found on the landside of the levee looking downstream.

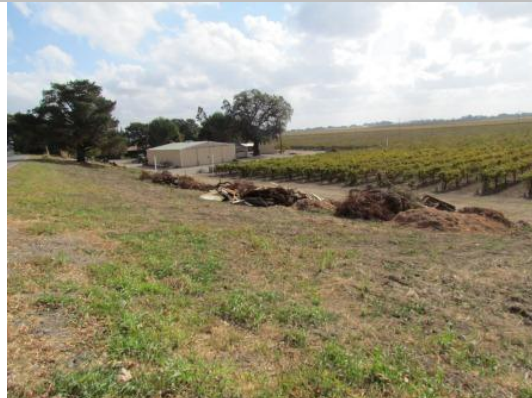
Photo 4 of 4 : FA\_2014\_RD0150\_17\_51\_20141021\_00046.jpg

Updated picture of the pruning pile on the landside of the levee looking upstream during the fall 2013 inspection.

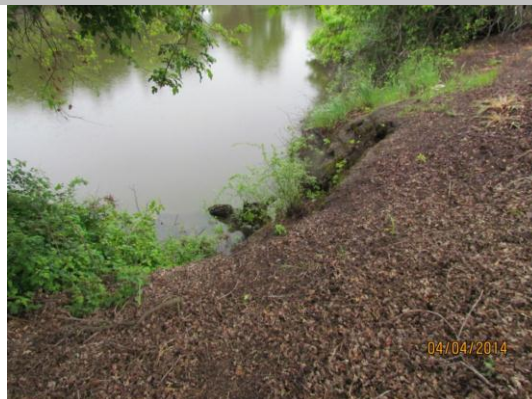
Photo 1 of 1 : FA\_2014\_RD0150\_17\_80\_20141021\_00083.jpg

LM Start	4.57	Rating **	M	Issue No.	80
LM End	4.57	Issue Type +	Ma	Location *	WS
Category	Earthen Levee			GPS Latitude/Longitude	
				Start	End
Item	Erosion / Bank Caving			38.374355 °	38.374355 °
				-121.547436 °	-121.547436 °
DWR ID	DWR_RD0150_03_s_2014_80				
Action/Comments					
Schedule repair of erosion site prior to the next inspection.

View of an erosion site on the waterside toe of the levee looking upstream.

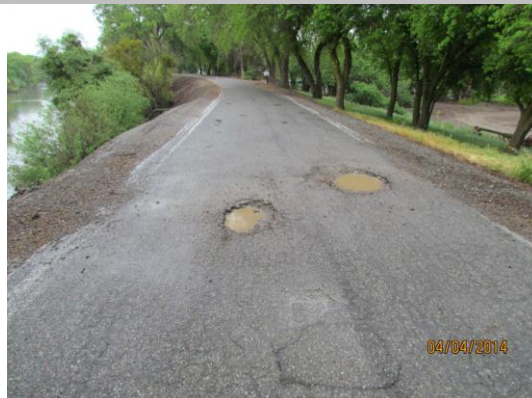
Photo 1 of 2 : FA\_2014\_RD0150\_17\_65\_20141021\_00063.jpg

LM Start	<b>4.95</b>	Rating **	M	Issue No.	<b>65 (cont)</b>
LM End	<b>4.95</b>	Issue Type +	Ma	Location *	CR

Updated view of the crown depression during spring 2014 inspection.

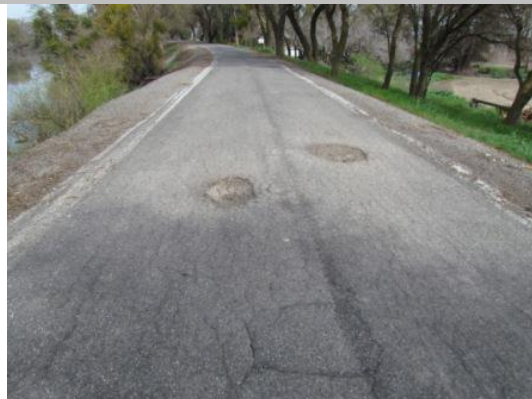
Photo 2 of 2 : FA\_2014\_RD0150\_17\_65\_20141021\_00064.jpg

Crown depressions were found during spring 2013 inspection looking upstream.

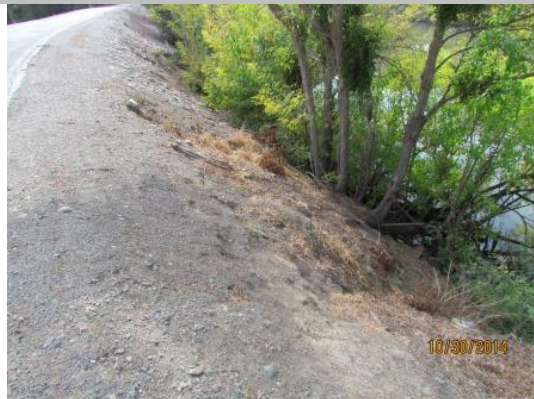
Photo 1 of 1 : FA\_2014\_RD0150\_17\_81\_20141104\_00125.jpg

View of erosion on the waterside of the levee looking downstream.

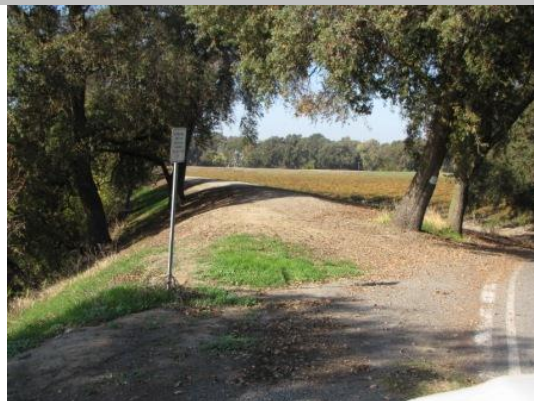
Photo 1 of 1 : FA\_2014\_RD0150\_17\_941\_20141021\_00105.jpg

View of varying elevations in the crown of the levee at the transition from county road to access road.

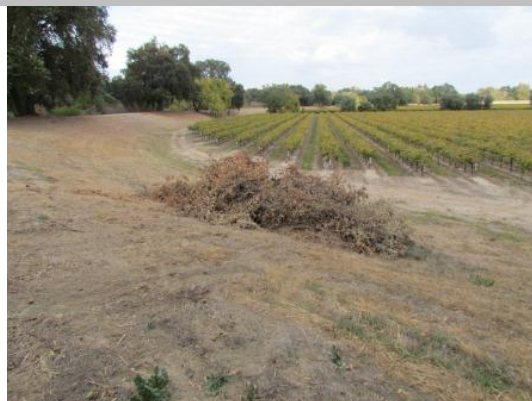
Photo 2 of 4 : FA\_2014\_RD0150\_17\_12\_20141021\_00009.jpg

LM Start	5.61	Rating **	M	Issue No.	12 (cont)
LM End	5.61	Issue Type +	En	Location *	LS
Category	Earthen Levee			GPS Latitude/Longitude	
				Start	End
Item	Encroachments			38.383328 °	38.383328 °
				-121.545825 °	-121.545825 °
DWR ID	DWR_RD0150_03_s_2012_12				
Action/Comments					
Prunings

Updated picture of pruning pile on the landside toe of the levee looking upstream during the fall 2013 inspection.

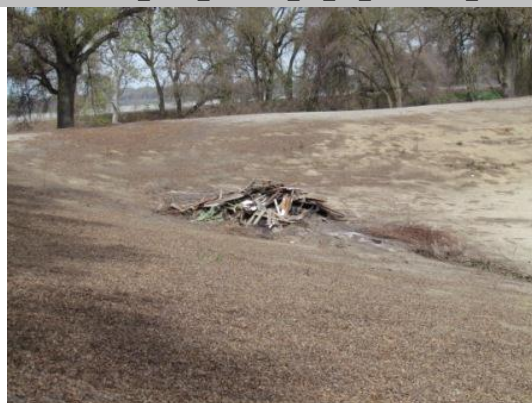
Photo 3 of 4 : FA\_2014\_RD0150\_17\_12\_20141021\_00010.jpg

Updated picture of debris and pruning on the landside toe of the levee looking upstream. This picture was taken during spring 2013 inspection.

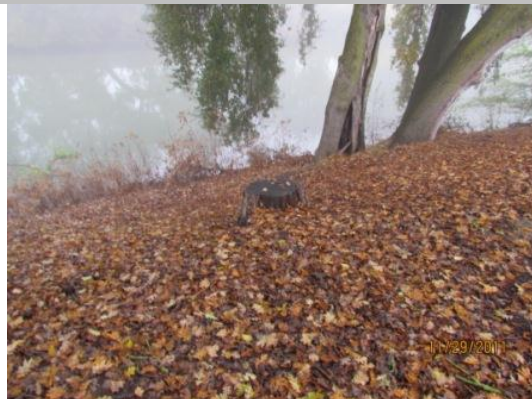
Photo 1 of 1 : FA\_2014\_RD0150\_17\_68\_20141021\_00069.jpg

LM Start	5.66	Rating **	N	Issue No.	68
LM End	5.66	Issue Type +	Ma	Location *	WS
Category	Earthen Levee			GPS Latitude/Longitude	
				Start	End
Item	Trim / Thin Trees			38.383697 °	38.383697 °
				-121.545201 °	-121.545201 °
DWR ID	DWR_RD0150_03_s_2012_68				
Action/Comments					
Tree stumps.

Tree stump was found on the waterside of the levee looking upstream.

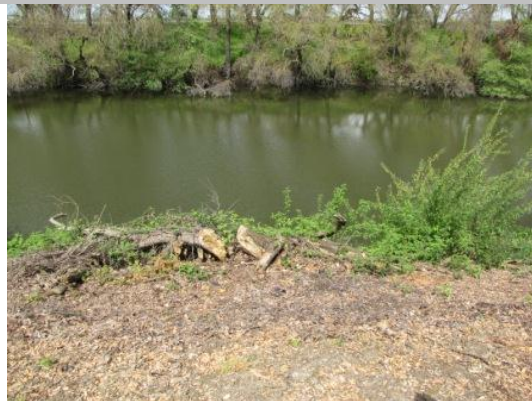
Photo 1 of 1 : FA\_2014\_RD0150\_17\_49\_20141021\_00040.jpg

LM Start	6.34	Rating **	N	Issue No.	49
LM End	6.34	Issue Type +	Ma	Location *	WS
Category	Earthen Levee			GPS Latitude/Longitude	
				Start	End
Item	Trim / Thin Trees			38.389658 °	38.389658 °
				-121.541518 °	-121.541518 °
DWR ID	DWR_RD0150_03_s _ 2012_49				
Action/Comments					
Tree stumps.

View of tree stumps on the waterward slope.

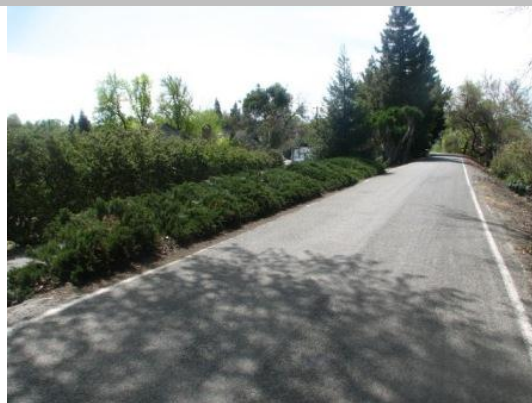
Photo 1 of 1 : FA\_2014\_RD0150\_17\_26\_20141021\_00018.jpg

LM Start	6.37	Rating **	M	Issue No.	26
LM End	6.40	Issue Type +	En	Location *	LS
Category	Earthen Levee			GPS Latitude/Longitude	
				Start	End
Item	Vegetation			38.389858 °	38.390115 °
				-121.541155 °	-121.540657 °
DWR ID	DWR_RD0150_03_s _ 2012_26				
Action/Comments					
Landscaping

Landscaping on landward slope blocking view from LM 6.37 to 6.40

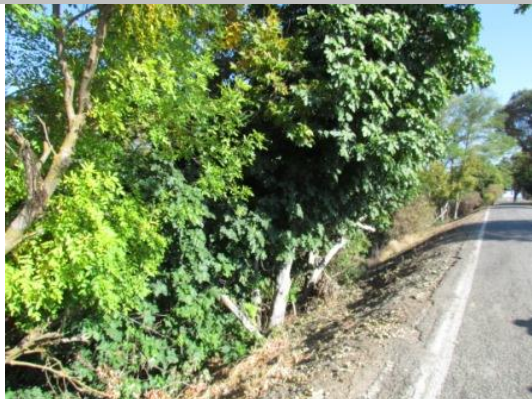
Photo 1 of 2 : FA\_2014\_RD0150\_17\_62\_20141021\_00059.jpg

LM Start	<b>6.49</b>	Rating **	M	Issue No.	<b>62 (cont)</b>
LM End	<b>6.49</b>	Issue Type +	Ma	Location *	WS

Tree was blocking the visibility on the waterside of the levee looking upstream. This picture was taken during fall 2012 inspection.

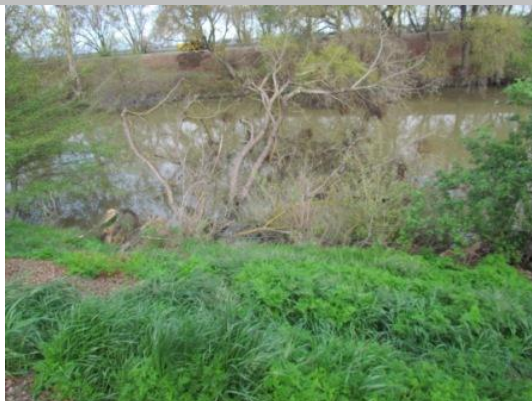
Photo 2 of 2 : FA\_2014\_RD0150\_17\_62\_20141021\_00060.jpg

Vegetation on the waterside of the levee looking downstream.

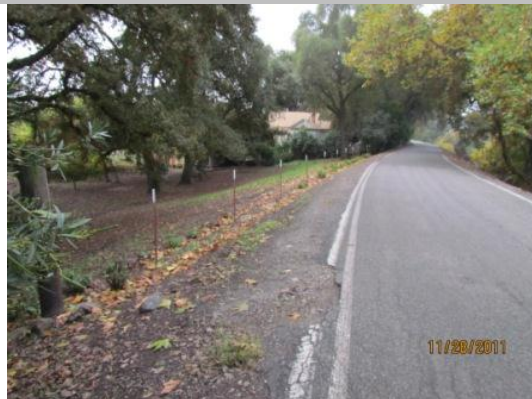
Photo 1 of 1 : FA\_2014\_RD0150\_17\_13\_20141021\_00012.jpg

LM Start	6.93	Rating **	M	Issue No.	13
LM End	6.95	Issue Type +	En	Location *	LS
Category	Earthen Levee			GPS Latitude/Longitude	
				Start	End
Item	Encroachments			38.395470 °	38.395998 °
					° -121.536613 °
DWR ID	DWR_RD0150_03_s_2012_13				
Action/Comments					
Fence

Fence was found on the landside of the levee looking downstream.

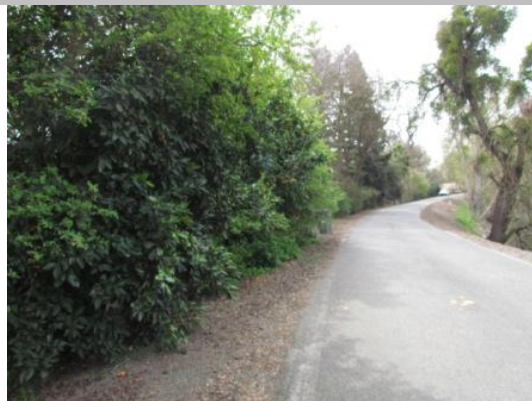
Photo 1 of 1 : FA\_2014\_RD0150\_17\_933\_20141021\_00099.jpg

LM Start	6.98	Rating **	M	Issue No.	933
LM End	7.04	Issue Type +	En	Location *	LS
Category	Earthen Levee			GPS Latitude/Longitude	
				Start	End
Item	Vegetation			38.396187 °	38.396989 °
				-121.536180 °	-121.535151 °
DWR ID	DWR_RD0150_03_s_2012_933				
Action/Comments					
Landscaping					
Inspector Comments: Landscaping has been maintained better, but some obstructions still exist.

View of the landscape on the landside shoulder of the levee looking downstream.

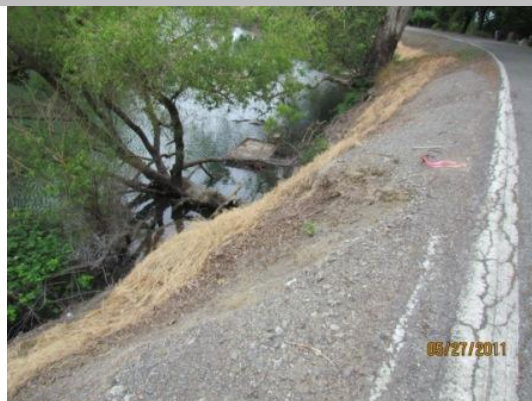
Photo 4 of 4 : FA\_2014\_RD0150\_17\_61\_20141021\_00055.jpg

LM Start	7.02	Rating **	M	Issue No.	61 (cont)	
LM End	7.02	Issue Type +	Ma	Location *	WS	
Category	Earthen Levee			GPS Latitude/Longitude		
				Start		End
Item	Erosion / Bank Caving			38.396655 °	38.396655 °	
				-121.535485 °	-121.535485 °	
DWR ID	DWR_RD0150_03_s_2012_61					
Action/Comments						
Note and monitor erosion site.

Updated erosion site picture on the waterside slope of the levee looking upstream during spring 2011 inspection.

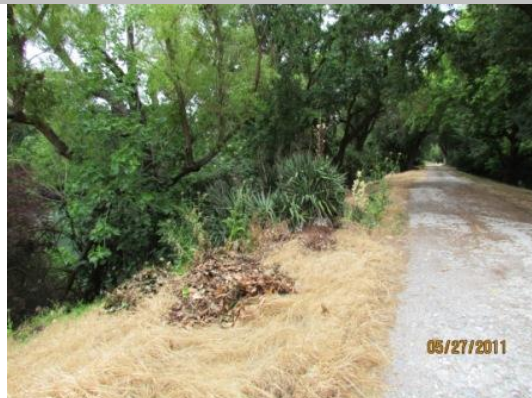
Photo 1 of 1 : FA\_2014\_RD0150\_17\_64\_20141021\_00062.jpg

LM Start	7.39	Rating **	M	Issue No.	64
LM End	7.39	Issue Type +	En	Location *	WS
Category	Earthen Levee			GPS Latitude/Longitude	
				Start	End
Item	Vegetation			38.401481 °	38.401481 °
				-121.536876 °	-121.536876 °
DWR ID	DWR_RD0150_03_s_2012_64				
Action/Comments					
Landscaping

Landscaping on the waterside of the levee. The picture was taken from the crown looking upstream.

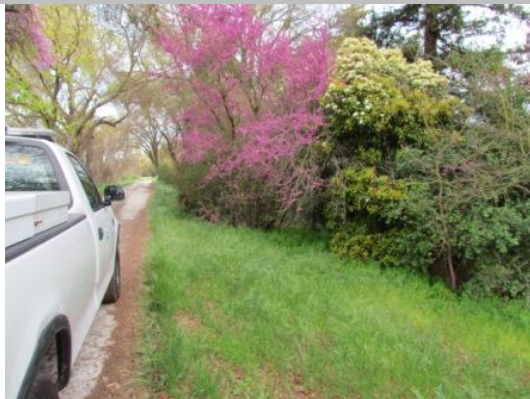
Photo 1 of 2 : FA\_2014\_RD0150\_17\_32\_20141021\_00023.jpg

LM Start	7.42	Rating **	M	Issue No.	32
LM End	7.47	Issue Type +	En	Location *	LS
Category	Earthen Levee			GPS Latitude/Longitude	
				Start	End
Item	Vegetation			38.401738 °	38.402296 °
				-121.537127 °	-121.537678 °
DWR ID	DWR_RD0150_03_s_2012_32				
Action/Comments					
Landscaping

Vegetation on the landside of the levee looking upstream. This picture was taken during spring 2012 inspection.

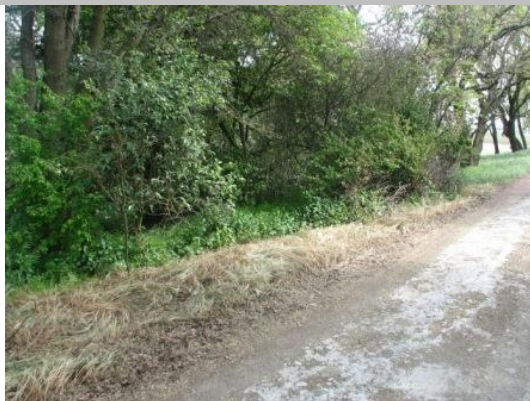
Photo 2 of 2 : FA\_2014\_RD0150\_17\_32\_20141021\_00024.jpg

Landscaping on landward slope blocking view from LM 7.42 to 7.47

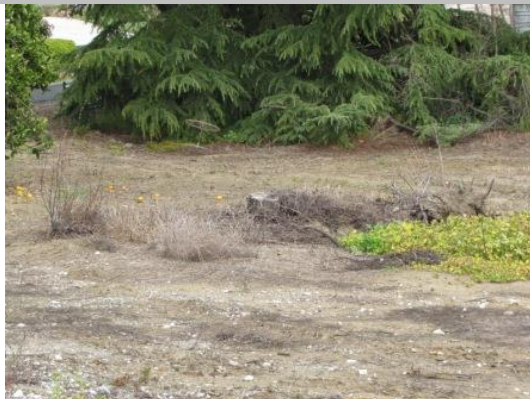
Photo 1 of 1 : FA\_2014\_RD0150\_17\_63\_20141021\_00061.jpg

LM Start	7.50	Rating **	N	Issue No.	63
LM End	7.50	Issue Type +	Ma	Location *	LS
Category	Earthen Levee			GPS Latitude/Longitude	
				Start	End
Item	Trim / Thin Trees			38.402779 °	38.402779 °
				-121.538197 °	-121.538197 °
DWR ID	DWR_RD0150_03_s_2012_63				
Action/Comments					
Tree stumps.

View of a tree stump on the landward slope.

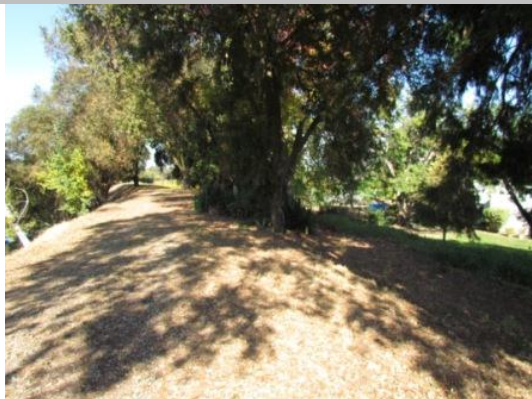
Photo 1 of 1 : FA\_2014\_RD0150\_17\_84\_20141021\_00084.jpg

LM Start	7.54	Rating **	M	Issue No.	84
LM End	7.54	Issue Type +	En	Location *	LS
Category	Earthen Levee			GPS Latitude/Longitude	
				Start	End
Item	Vegetation			38.403047 °	38.403047 °
				-121.538433 °	-121.538433 °
DWR ID	DWR_RD0150_03_s_2012_84				
Action/Comments					
Landscaping

Landscaping was found on the landside shoulder of the levee looking upstream.
